EXPERT REPORT

In re Flint Water Cases
Civil Action No.5:16-cv-10444-JEL-EAS
(consolidated)

David C. Crowe, Ph.D.
5835 Windknoll Court, Cincinnati, OH 45243-2966

February 3, 2023

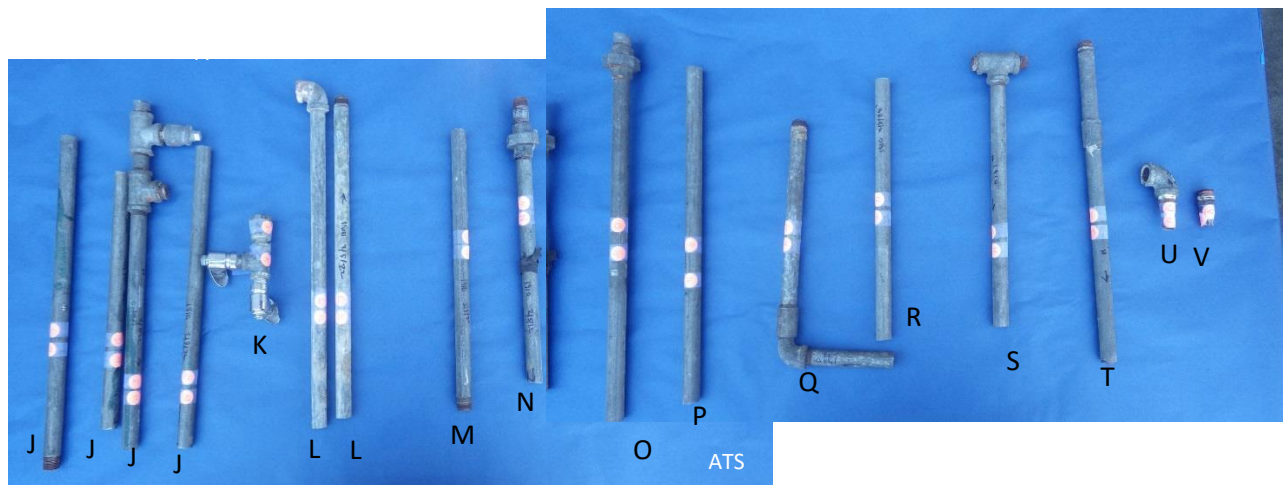
Figure 1. Samples of pipe laid out on the larger table.

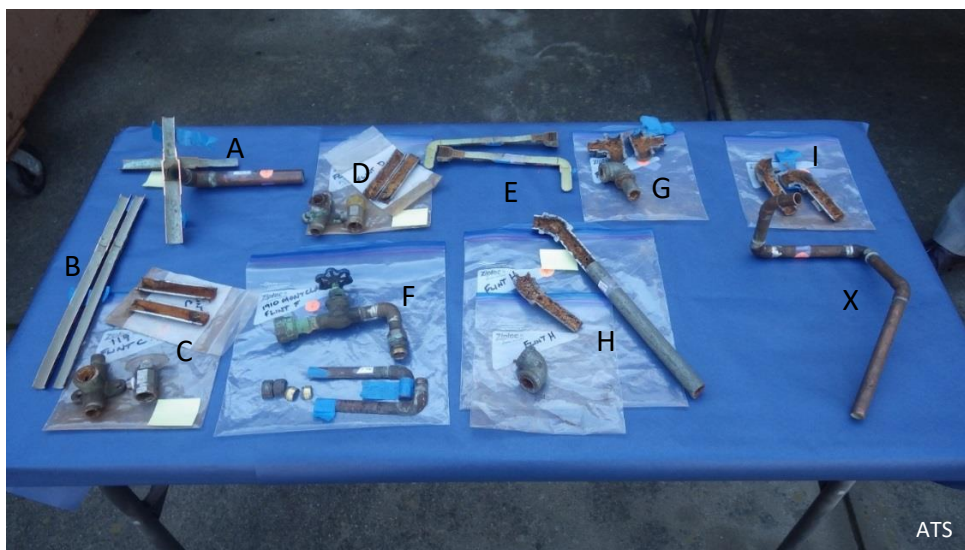
Figure 2. Samples on the smaller table.

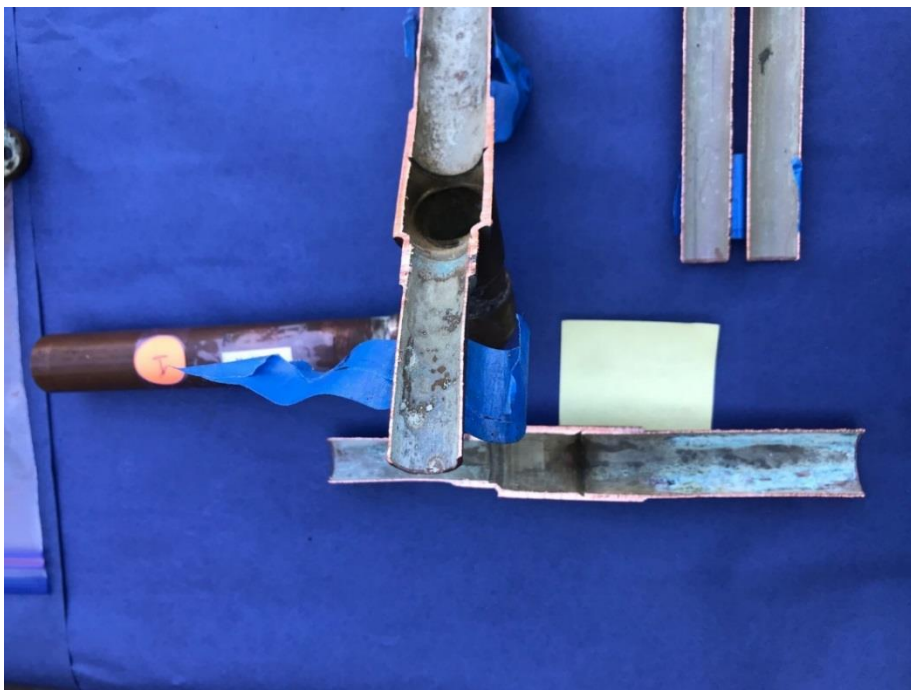
In **Figures 3 and 4**, variations in the wall thickness were seen between the pipe and fitting, but there was no evidence of corrosion of the inside surface at thinner areas. The thin scale is typical of scale seen in copper water pipes. The pipe thickness and general appearance were typical of copper pipe that has been in service for a few years. The areas of greenish scale may be related to flux residue which was left on the pipe during soldering. The remaining corrosion product from flux supports the position that no significant damage has occurred, particularly during the water crisis period, otherwise that corrosion product from flux would have been removed.

Evidence of superficial scratches on the inside surface appeared to have been from removal of loose scale for analysis by Dr. Russell. This scratch did not appear to have removed a constant thickness, or all of the oxide in one area, and the area was uncontrolled, so deposit composition measured by Dr. Russell may not be representative.

Figure 3. Sample A, copper hot water pipe, with greenish corrosion product.

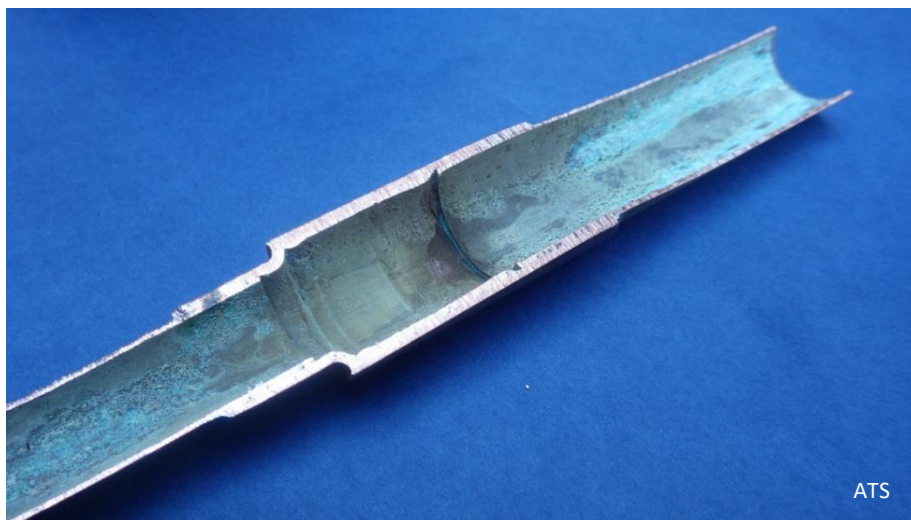
Figure 4. Sample A – Copper hot water line, with green corrosion product likely from flux residue.

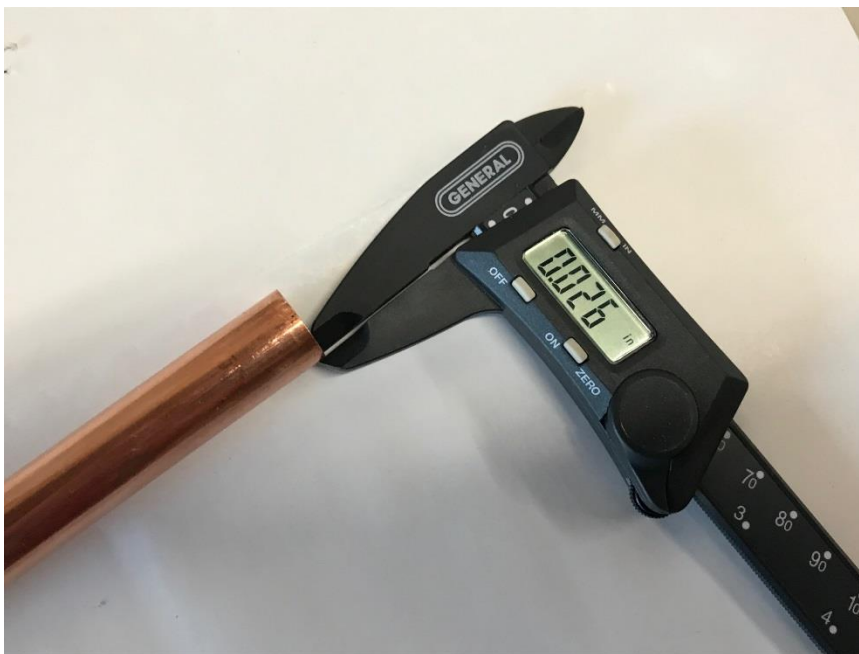
For comparison, I obtained a section of new Type M ½-inch copper tube from Home Depot on January 26, 2023 and measured the wall thickness of the copper tube with calipers, as illustrated in **Figure 6**. The thickness at four points 90° apart around the circumference was 0.026, 0.027, 0.026 and 0.027 inches. These measurements met the specification for new Type M copper tube ½-inch diameter which is 0.028±0.003 inch. These comparison measurements show that the copper tube in the [REDACTED] home was 'as-good-as-new' in terms of thickness.

Figure 6. The wall thickness of a piece of new Type M 1/2-inch copper pipe was measured at 0.026, 0.027, 0.026 and 0.027 at four points 90° apart around the circumference. The measurement of 0.026 meets the nominal thickness for the pipe, which is 0.028±0.003 inches.

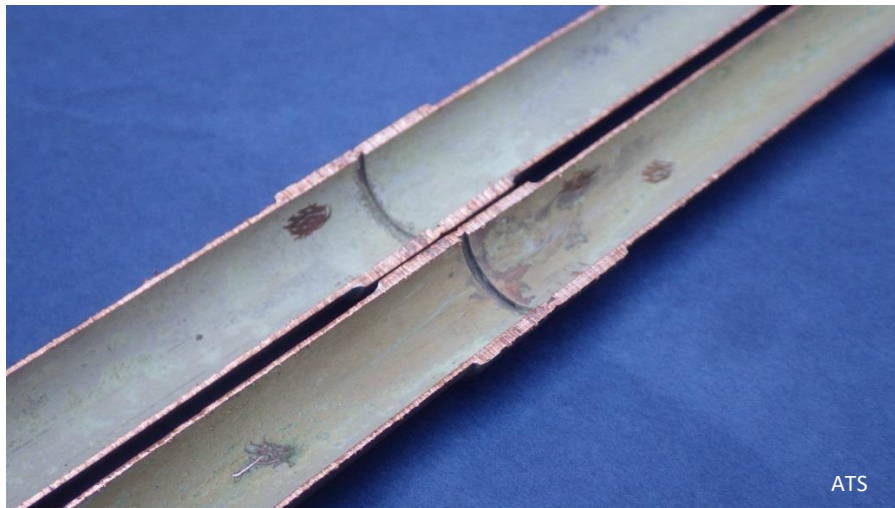
Figure 7. Sample B, Copper cold water line from [REDACTED]

The internal surface was in excellent condition, with no damage. It was covered with a thin layer of oxide, typical for copper pipe. It had been scraped off in one location. There was no evidence of pitting or localized corrosion. The outside surface had greenish corrosion products from flux residue.

The oxide on the inside of the copper pipe was very thin, on the order of nanometers, so it would have been impractical to obtain a sufficient sample for ICAPS analysis of lead. However, considering the thinness of the oxide, no significant reservoir of lead would be expected to be present. The thin oxide also could not conceal damage – and none was seen.

I measured the thickness at the end cut using calipers, but a burr on the edge of the sample precluded an accurate measurement.

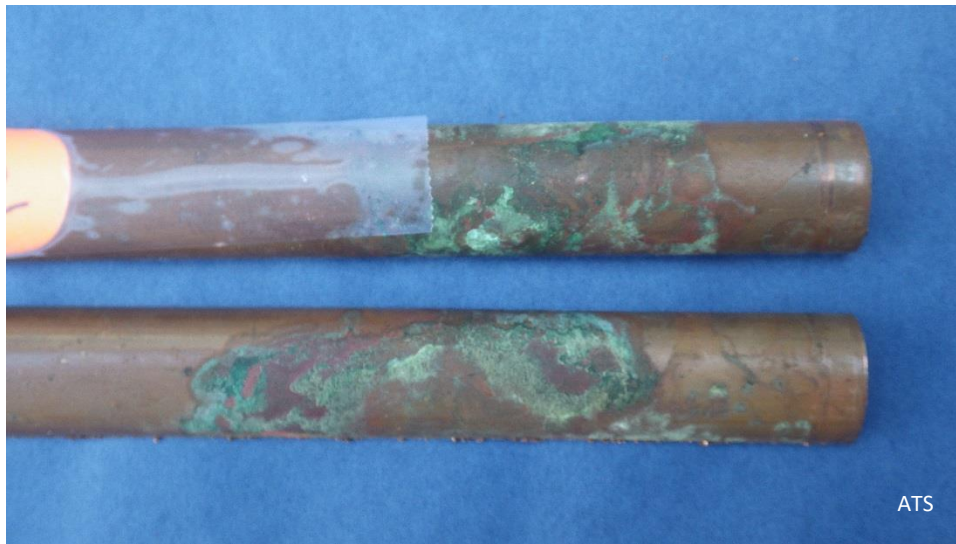
Figure 8. Sample B, copper cold water pipe with corrosion product from flux on the outside surface. This corrosion product is external only, and does not correspond to any area of attack inside.

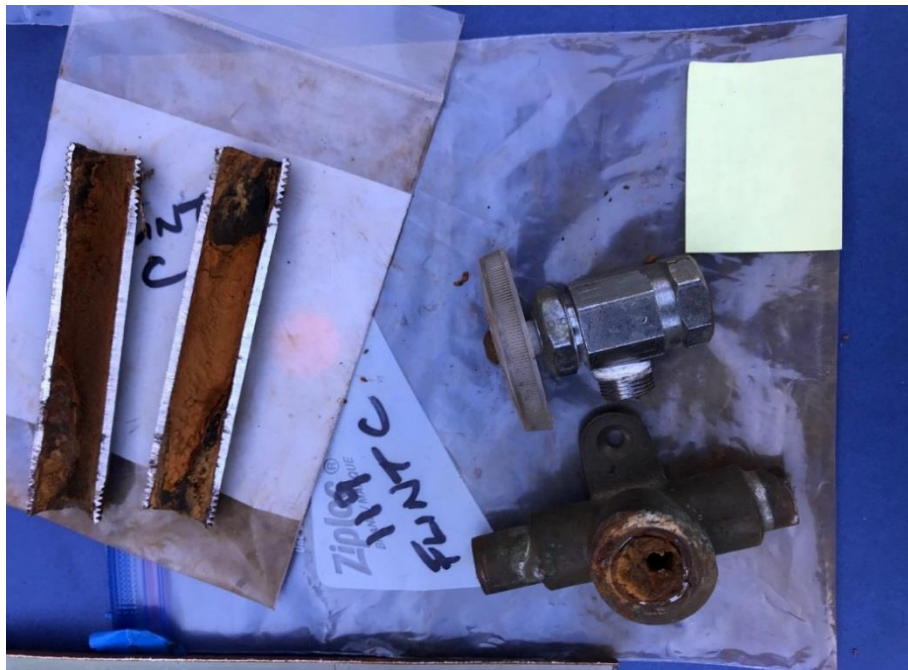
The location of removal of Sample C can be seen in Fig. 7 of the home inspection report (2), but Dr. Russell did not cut out this sample, and it was found in the basement by him. Sample C, **Figures 9 and 10**, shows no evidence of significant wall loss, but the cut surface, where the sample was sawn longitudinally, has rusted after cutting. The internal scale was less voluminous than in some other pipe samples. Variations in color are typical of scales in steel pipes, and may result from differences in oxidation state of the rust, or may result if top layers are knocked off during handling. Dr. Russell's report did not discuss galvanized pipe at [REDACTED], and did not claim damage of the galvanized line there. He did perform scale analysis via ICAPS and found 114 mg/kg lead. Expressed at weight percent of the deposit, it is 0.0114%. This lead is likely residual from the lead that was present in the original zinc galvanizing layer.

Figure 9. Sample C, galvanized steel pipe and valve apparently from the cold water line to the upstairs bathroom sink. The valve is heavily scaled inside with deposits similar to the inside of the pipe, and did not appear to be typical of corrosion products from dezincification.

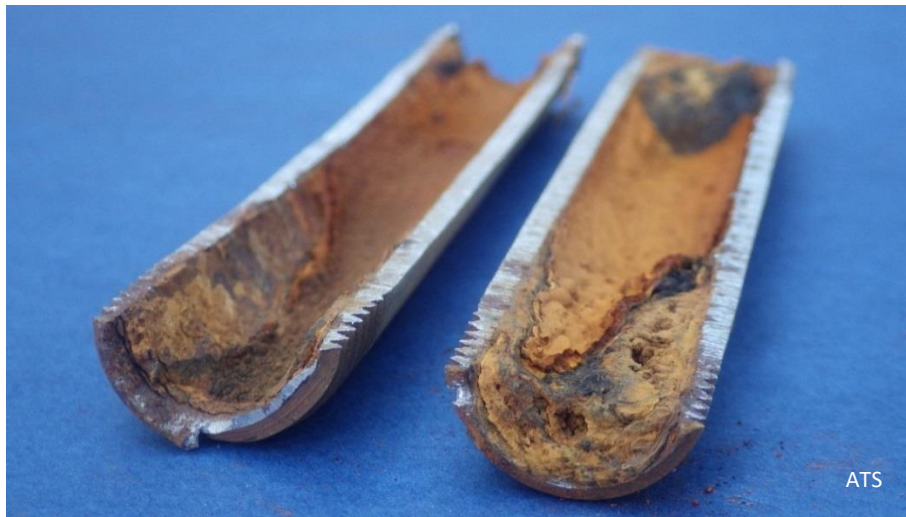
In **Figure 10**, note the ends of the sample sections, which are threaded. During fabrication of the piping joints, threads are cut in the ends. This cutting breaks and removes the galvanized coating layer, exposing the steel to the atmosphere, which corrodes from the exterior. Also note that the threads are cut deeper as they approach the end of the pipe, resulting in thin wall at the root of the thread. When disassembling old pipe, it is often this thinned area at the root that tears before the rusted joint is loosened. Steel-to-steel joints rust tightly due to oxide corrosion product forming between the teeth, and due to its higher volume compared to the steel it came from, forming a joint with compressive stresses which must be overcome during opening. Good pipe sampling technique would call for samples to be cut out where possible, not disassembled with wrenches, which could cause mechanical damage to the samples. There is no apparent reason why Dr. Russell could not have used a pipe cutter instead of wrenching the samples loose, causing damage.

Figure 10. End view of Sample C. Note the full wall thickness and rust on the cut surfaces.

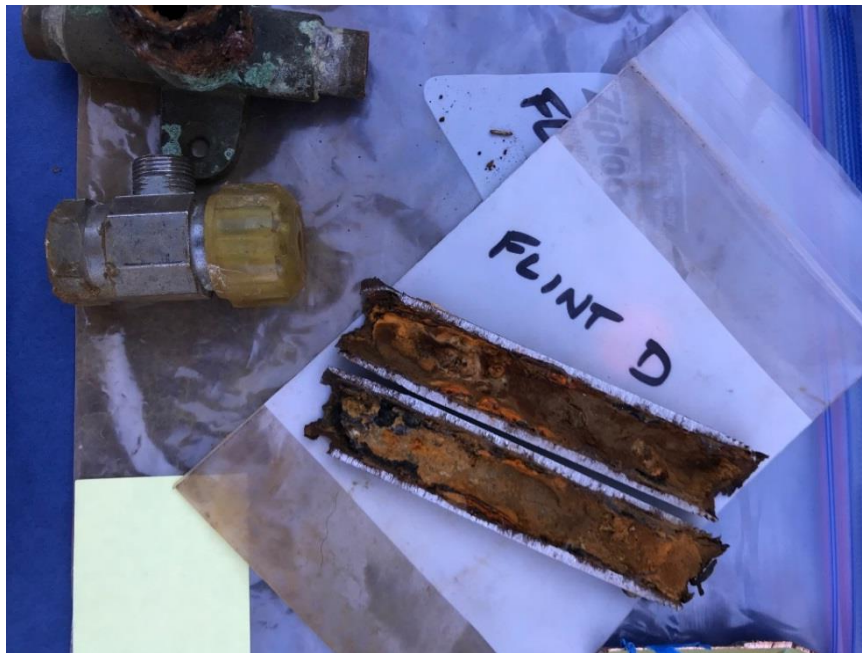
The location of removal of sample D is illustrated in Fig. 7 of the home inspection report (2), but Dr. Russell did not cut out this sample, and it was found in the basement by him. The pipe wall of Sample D, **Figure 11**, showed rusting of the cut surface, but this was superficial flash rusting of a fresh surface exposed to moisture. This observation points to the likelihood that the samples were poorly stored and, at some point, were wet during storage. **The wall had not lost thickness, despite the cross-section appearance that it had corroded.** Heavier scale in Sample D compared to Sample C may be because Sample D was from the hot water side, and more corrosion would be expected in hot water. Dr. Russell's ICAPS analysis (4) found 145 mg/kg lead in the scale, that is, 0.0145% by weight. This is likely residual lead from the original zinc galvanizing layer. EDS showed that the scale was mostly iron oxide. There was significant corrosion at the junction of the pipe with a fitting, **Figures 12 and 13**. This is typical of old galvanized piping systems. XRF analysis by ATS (1) showed that this fitting with bracket contains copper, lead, and zinc, consistent with brass. The end of the pipe in the foreground of **Figure 12** shows external corrosion and tearing failure at the threads during disassembly as already discussed.

Figure 11. Sample D, galvanized steel hot water pipe apparently from the upstairs bathroom sink, with shut-off valve.

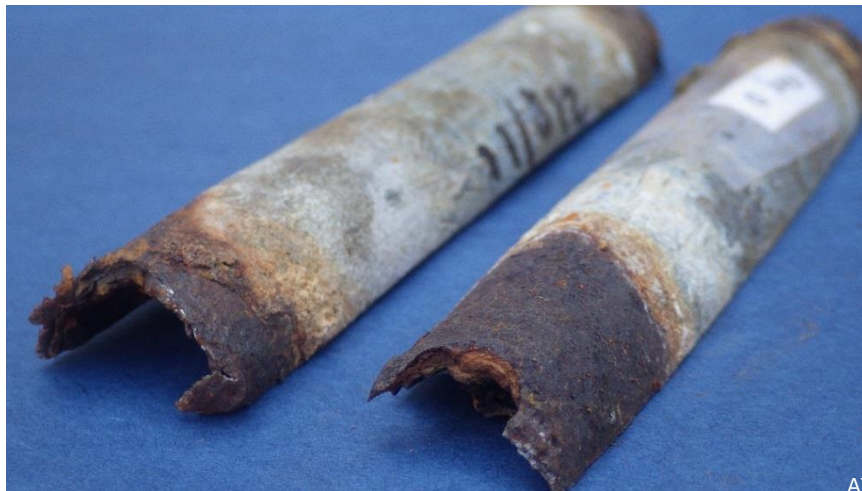
Figure 12. Sample D, galvanized steel hot water pipe from upstairs bathroom illustrating corrosion at the brass fitting, where damage to the galvanized coating by threading had permitted corrosion.

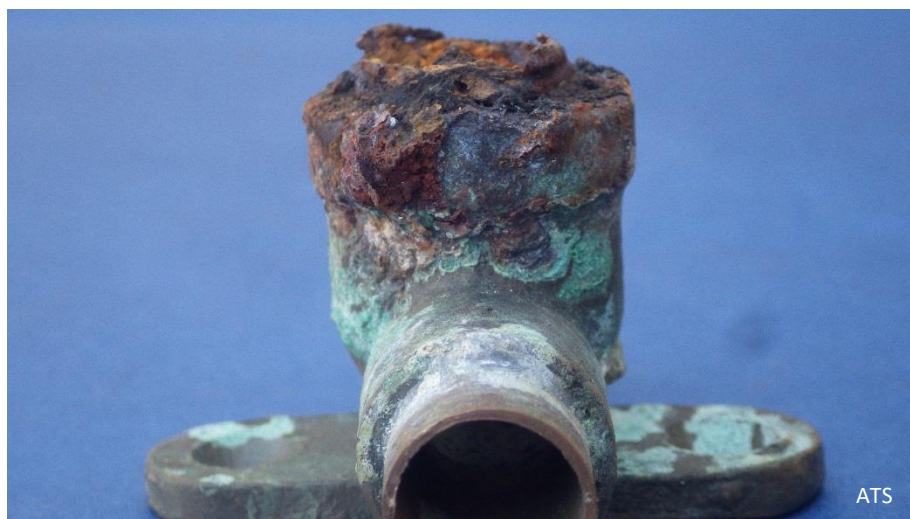
Figure 13. Sample D, fitting with corroded galvanized steel hot water pipe in the end, from the upstairs bathroom at [REDACTED]

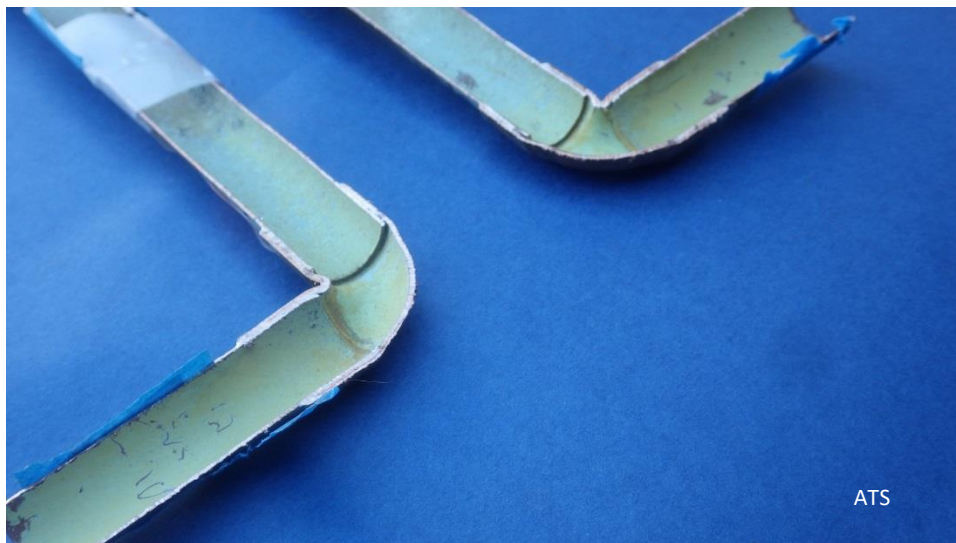
Figure 14. Sample E, hot water pipe at the water heater.

Sample E is shown in **Figure 14**. Its location was illustrated in Fig.4 of the home inspection report (3). Note the thin, uniform oxide on the internal surface. It was Fig. 4.2-1 and 4.2-2 in the Russell report (4). Dr. Russell reportedly measured a thickness of 0.019-in. but gave no indication of where he had measured. Visually, the outside of the bend was thinner due to stretching when the bend was formed. It should be noted that the elbow does not appear to be made to a specification. The sharp inside (intrados) bend has a crimped appearance which is not acceptable and the extrados is flattened and thinned in appearance. This elbow appears to be homemade. **Figure 15**, further below, shows a similar elbow, and it does not meet specifications (or sample elbows available for purchase). Note the thick wall on the intrados and the thicker wall on the extrados where the tube has been stretched around the bend. Because these elbows are not spec grade, there is no information on their original thickness when new.

There was also thin tube adjacent to the fitting, and that may have been abraded during fit-up to fit it into the fitting; this is not evidence of corrosion. Internal surface examination would be required to determine whether corrosion may have occurred, but the scale uniformity suggests that no corrosion ever occurred. There is no visual evidence of attack or damage on this sample.

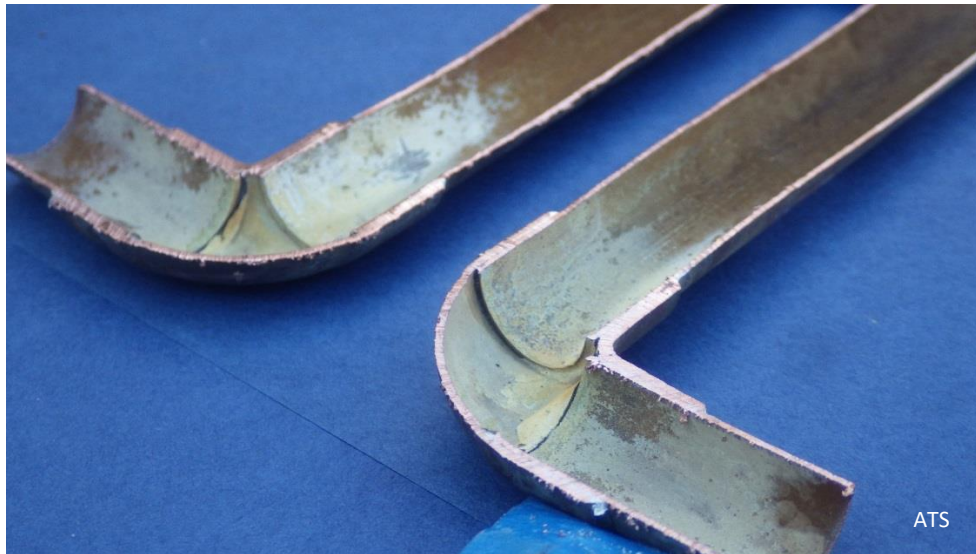
Figure 15. Sample F, copper cold water pipe at the water heater.

The location of Sample F is believed to be shown in Fig. 4 of the home inspection report (3). Sample F, illustrated in **Figure 15**, corresponds to Fig. 4.2-3 and 4.2-4 in Dr. Russell's report (4). No attack or damage is seen on this sample. Dr. Russell measured 0.026-in. thickness but our measurements with calipers showed it to be 0.034-in. and higher. We do not know where Dr. Russell measured, and it may have been on the extrados of the elbow bend, or at the joint which was abraded to fit into the bend. As already discussed for Sample A, the tolerance specification of the Type M piping allows a thickness of 0.025-inch, so there is no evidence here of any loss of thickness. Visually, we do not see any evidence of damage.

Caliper measurements could not be performed in some places to confirm thickness due to a cutting burr on the end edge of the sample. Where the burr was missing, all measurements made were well over the thickness claimed by Russell in his Opinion 5-5.

Russell reported analysis showing there was no lead in the solder joints. He detected lead in the scale of a brass coupling, and that lead would be part of the brass alloy, not a contaminant.

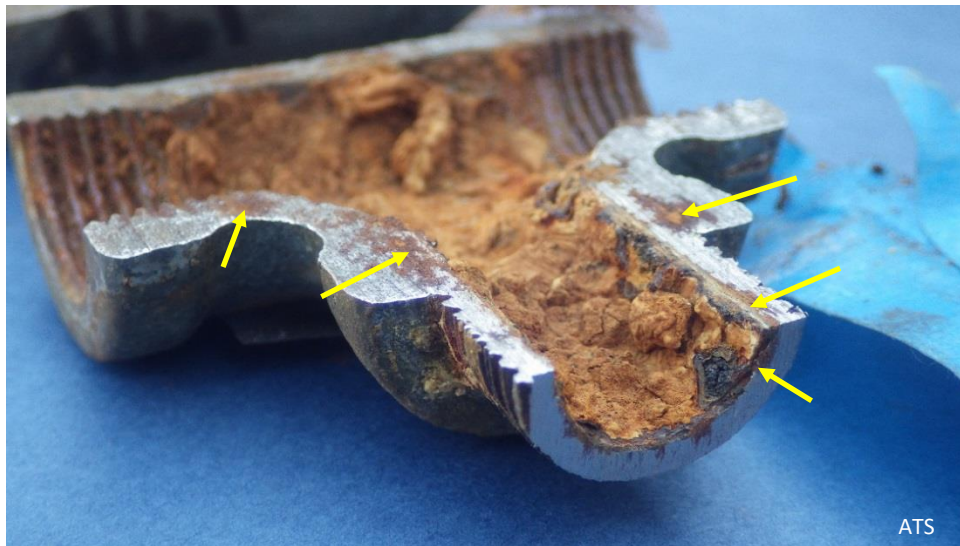
Figure 16 illustrates Sample G, a tee with a pin-hole leak. The location of this sample may be shown in Fig.7 of the home inspection report (3). It is also shown in Figures 4.2-6 and 4.2-7 in Dr. Russell's report (4). There was heavy internal scale, but no evidence of significant wall loss, especially not areas that were 'paper thin' as claimed by Dr. Russell in his supplemental report Opinion 5-6 (4). Rusting of the cut surface, as indicated by yellow arrows in **Fig. 16**, points to poor storage of the samples. ICAPS (4) found 41.8 mg/kg lead in the scale (0.00418% by weight). Dr. Russell's EDS analysis found significant zinc, so some of the original zinc galvanizing layer may be present here, and would be expected to contain some lead as discussed under Sample C.

Corrosion of the fittings resulted in a weep spot where a pit has perforated the wall, and water has seeped out through corrosion deposits sealing the hole. These are typical of old galvanized piping. There is no way to tell when the weep spot formed (e.g. before, during or after 2014-2015). The age of the piping here is unknown, but if it dates from the construction of the house in 1938, then it has provided service well beyond its expected life. Usually a life of 40 to 60 years would be regarded as very good for galvanized piping (7), and this appears to have lasted 84 years.

Further cross-sectioning of the sample at the weep location would have aided in determining the cause. Upstream copper piping sheds copper, which can deposit onto the waterside of steel piping downstream. The copper acts as a cathode with the iron an anode, resulting in corrosion of the iron. This localized attack can lead to the formation of a tubercle. Dr. Russell overlooked this possibility, or any other, through his superficial failure analysis.

Figure 16. Sample G, internal surface of the tee in a galvanized line. A pinhole corrosion site is located underneath the scale. Rusting of the cut surface is indicated by the yellow arrows. This rusting is not indicative of through-wall pitting and does not compromise the integrity.

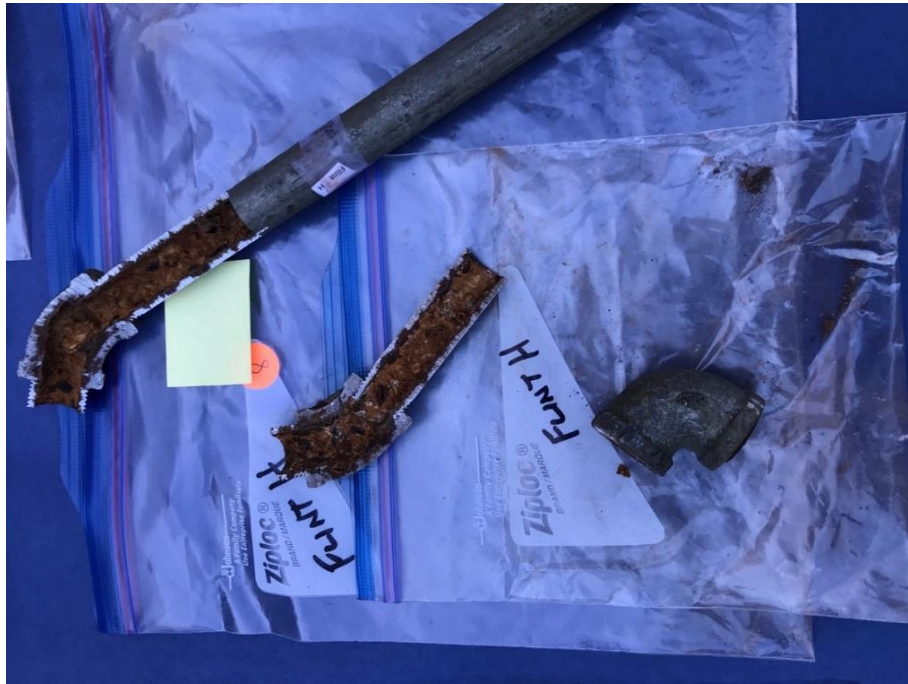
Sample H is shown in **Figures 17 and 18**. The location of the sample can be seen in Fig. 6 of the [REDACTED] house inspection report (3). The sample was illustrated in Figures 4.2-8 and 4.2-9 of Dr. Russell's report (4).

Heavy internal scale is seen when cross-sectioned. A weep mark on the exterior has resulted from an oxide-filled, through-wall pit. Weeps can be present for many years without progressing to an active leak. There were no active leaks observed during inspection of this home in 2020 (3). There is no general wall loss, and the dark stains on the cut surface are from rusting of the cut edge of the pipe. EDS of the scale by Dr. Russell (4) found significant amounts of zinc from galvanizing. Lead was below detection levels by EDS, but ICAPS found 168 mg/kg. This lead is likely from the original zinc galvanizing, as discussed for previous samples above.

Figure 17. Sample H, galvanized line with a through-wall pit.

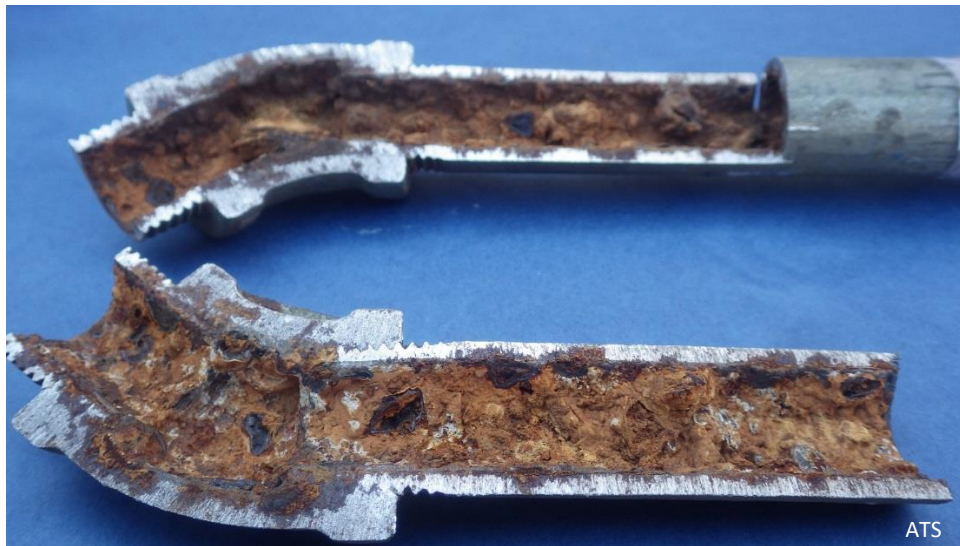
Figure 18. Sample H, close-up. The dark areas are where the red-brown scale has spalled off, revealing underlying black scale. This appearance of a red-brown surface rust, with darker form of rust underneath is typical in well-established corrosion of iron in water. There is no indication this was new scale. The discoloration on the cut surface is rust from poor storage, not corrosion or thinning into the pipe wall itself.

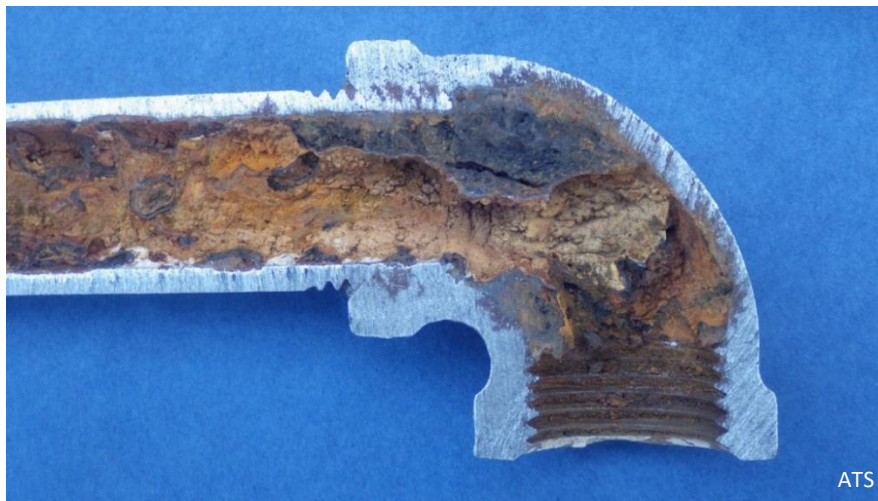
Sample I is shown in **Figure 19**. In Dr. Russell's report (4), this was in Figures 4.2-10 and 4.2-11. Thick scale was observed. The wall thickness appears to be uniform, suggesting that slow, uniform corrosion has occurred over the life of the pipe. Again, the discoloration on the cut surface is rust from poor storage, not corrosion or thinning into the pipe wall itself. EDS found zinc in the scale from galvanizing, and ICAPS found 83.3 mg/kg lead, again expected as a residual constituent of the galvanizing layer.

Figure 19. Sample I with thick scale at a bend. Note the rust on the cut surface from poor storage.

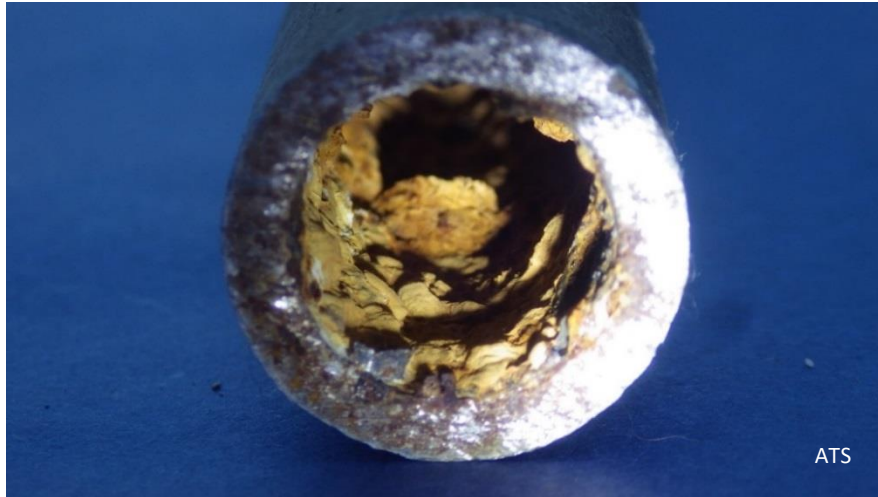
This sample was 4 pieces: ½ inch – 18.25, 14.125, 19 (tees), 16.5 inch, reportedly from a hot water line. The sections of pipe had traces of green paint on the exterior. Inside, heavy scale was observed, seen in **Figure 20**. In the Figure, note the thick wall of the pipe.

Figure 20. Sample J, galvanized pipe with thick scale seen from the end. Again, the cut surface was rusted.

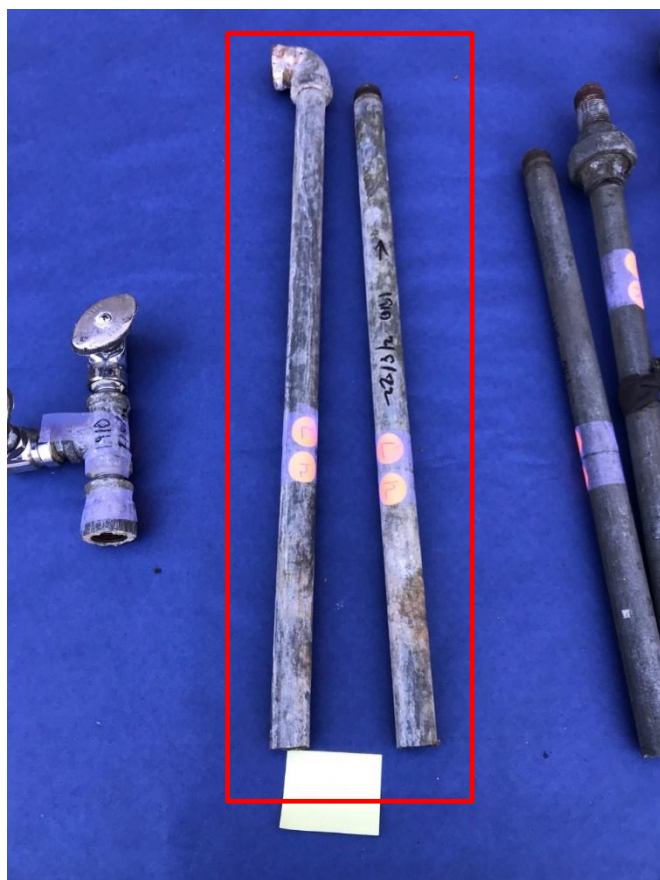
Figure 21. Sample L galvanized steel pipe in two sections.

Sample I was in two pieces, as seen in **Figure 21**. Both pieces have heavy internal scale **Figure 22**, preventing direct sight of light through the pipe. There was a weep spot from a through-wall pit on the 90-degree elbow.

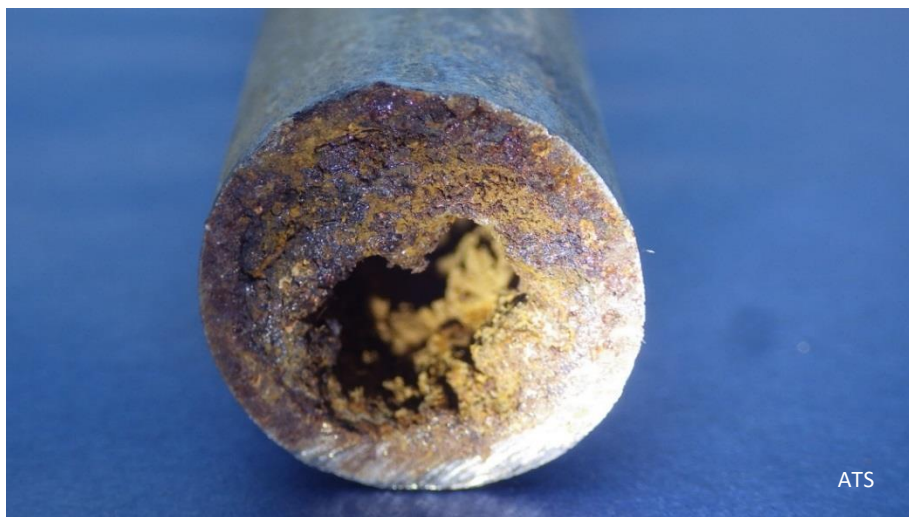
Figure 22. End view of Sample L, illustrating heavy internal scale but no compromise of the robust pipe wall.

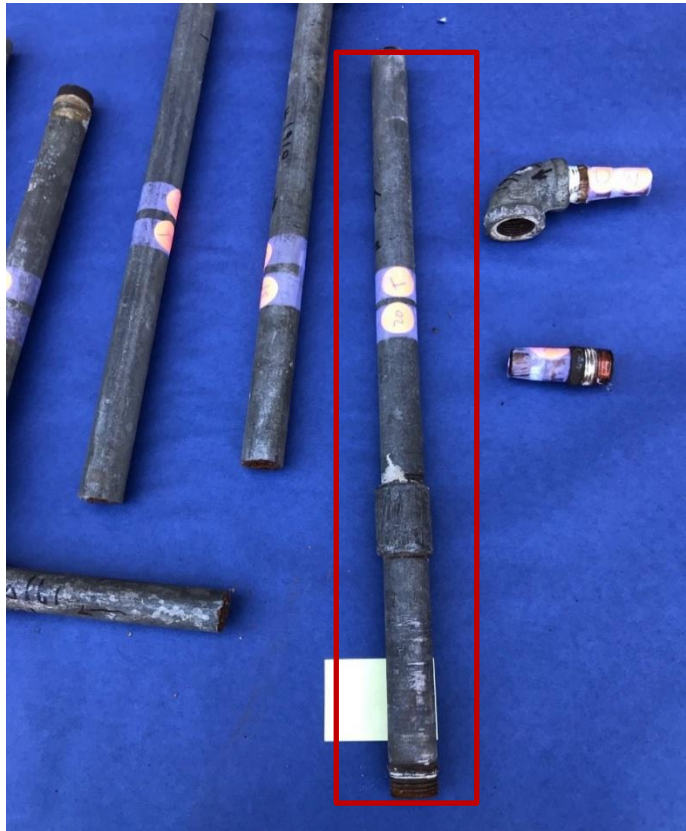
Sample T, shown in **Figure 23**, was obstructed with internal scale.

Figure 23. Sample T, in the red box, had heavy rust deposits inside.
